**WOOD DESTROYING PESTS AND ORGANISM INSPECTION REPORT**

Building No. <b>10835</b>	Street <b>Minette Drive</b>	City <b>Cupertino</b>	ZIP <b>95014</b>	Date of Inspection <b>3/16/2010</b>	Number of Pages <b>Page 1 of 6</b>
------------------------------	--------------------------------	--------------------------	---------------------	--	---------------------------------------

HomeGuard Rpt #: **139935**

General Description: <b>One story, single family wood framed residence with stucco and wood exterior.</b>	Inspection Tag Posted: <b>Garage</b>
	Other Tags Posted: <b>HomeGuard Inc. 2008</b>

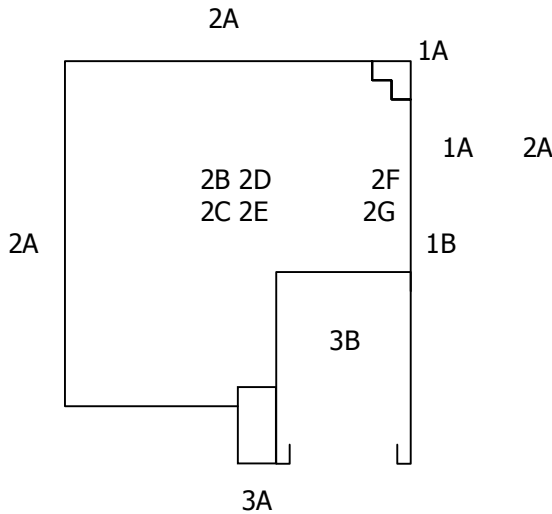
**FRONT**  
**Diagram Not To Scale**

**Key to Items on diagram: [1] Section 1 Items [2] Section 2 Items [3] Unknown Further Inspection Items**

**1A. FINDING:** Fungus damage was noted to the roof eaves as indicated on the diagram.

**3A.** FINDING: The abutments, as indicated on the diagram, are inaccessible for inspection.

**RECOMMENDATION:** Remove and replace the damaged wood members to correct this condition. This bid includes replacement of the roof covering if disturbed by our repairs. If existing gutters need to be removed to perform the repairs then our bid also includes reinstallation of original gutters. If it becomes necessary or desirable to install new gutters this will be done only if authorized and at an additional cost. The guarantees on the roof covering are limited to the areas where the work was performed

RECOMMENDATION: Install test holes through the exterior stucco to allow for further inspection. All findings, recommendations, and bids will be issued on a supplemental report.
